**Lands with Wilderness Characteristics Report:**  
**Grand Canyon Hills**  
**COF-020-057**

Area Unique Identifier: COF-020-057

**Royal Gorge Field Office Lands with Wilderness Characteristics Inventory, 2015: Evaluation of new information**

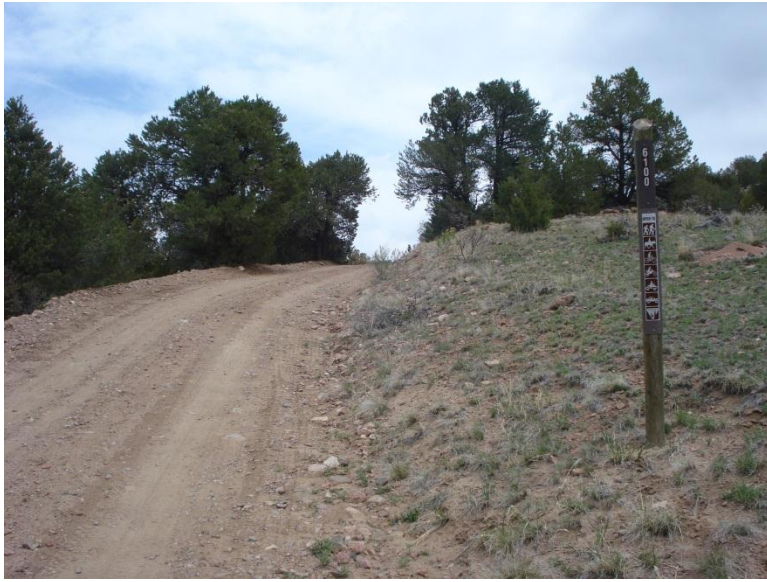
#1

<b>Date</b>	<b>Frame #</b>	<b>Camera Direc.</b>	<b>Description</b>	<b>GPS/UTM Location</b> (UTM Zone 13)	<b>Town -ship</b>	<b>Range</b>	<b>Sec.</b>	<b>Photo Point #</b>
5/22/2013	DSC03572	NE	Beginning of route, BLM 6100	N 4,252,776.5564  E 470,849.958525	19 S.	71 W.	4	1
5/22/2013	DSC03573	N	Route condition,	N 4,253,887.80862  E 472,662.357983	18 S.	71 W.	34	2
5/22/2013	DSC03574	N	Beginning of BLM 6100 C	N 4,253,887.80862  E 472,662.357983	18 S.	71 W.	34	3
5/22/2013	DSC03575	N	Beginning of BLM 6100 B	N 4,254,139.16329  E 472,741.733142	18 S.	71 W.	34	4
5/22/2013	DSC03576	E	Campfire ring at the end of BLM 6100	N 4,253,451.24525  E 473,733.922627	19 S.	71 W.	2	5
5/22/2013	DSC03578	W	Route condition, BLM 6100 B	N 4,254.588.95585  E 472,728.503949	18 S.	71 W.	34	6
5/22/2013	DSC03579	W	End of BLM 6100 B	N 4,253,755.51669  E 476,750.178659	18 S.	71 W.	34	7
5/28/2013	IMG_2013 0528_134 906	S	Grape Creek at the Arkansas River	N 4,253,755.51669  E 476,750.178659	19 S.	70 W.	6	8

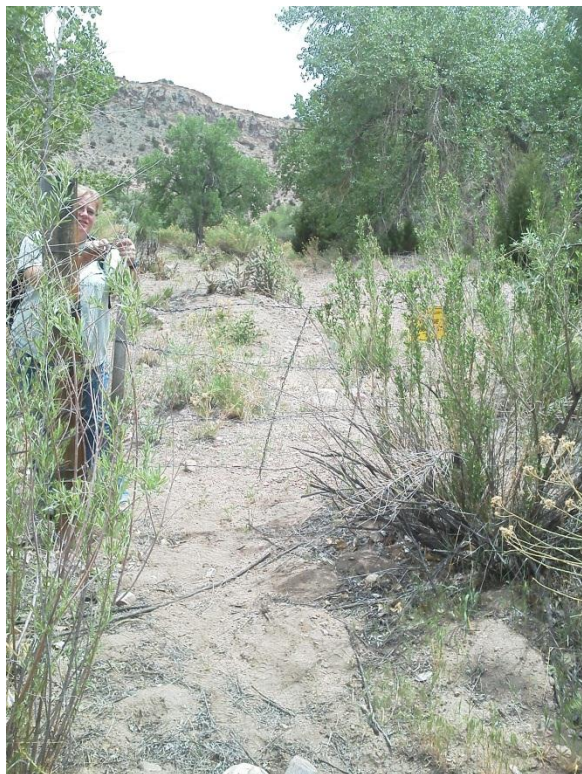
#9

5/28/2013	IMG_2013 0528_140 105	S	Walk thru gate at grape creek	N 4,253,755.51669	19 S.	70 W.	6	9

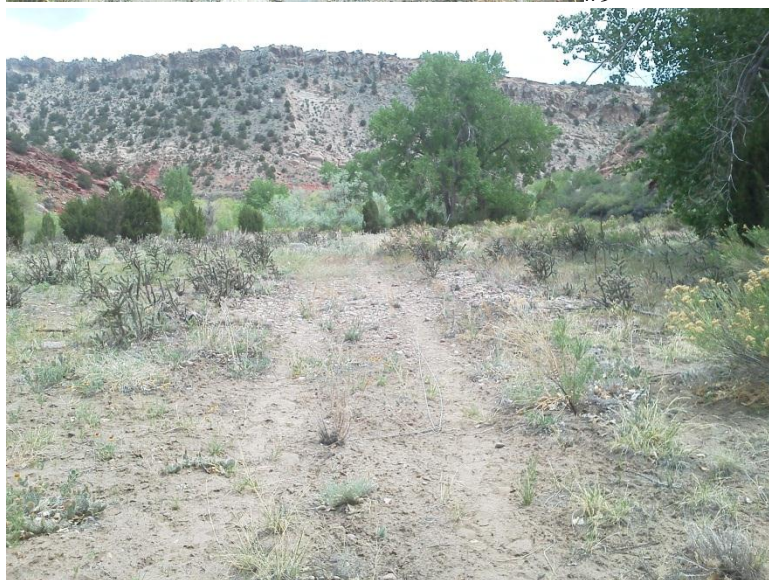
#10

E 476,750.178659				
5/28/2013	IMG_2013 0528_142 450	S	Vehicle tracks	N 4,253,755.51669  E 476,750.178659	19 S.	70 W.	6	10
5/28/2013	IMG_2013 0528_142 454	S	Vehicle tracks	N 4,253,755.51669  E 476,750.178659	19 S.	70 W.	6	11
5/28/2013	IMG_2013 0528_151 508	W	Route condition	N 4,253,755.51669  E 476,750.178659	19 S.	70 W.	6	12
5/28/2013	IMG_2013 0528_151 857	W	corals	N 4,253,755.51669  E 476,750.178659	19 S.	70 W.	6	13
5/28/2013	IMG_2013 0528_151 903	NE	Water line	N 4,253,755.51669  E 476,750.178659	19 S.	70 W.	6	14
5/28/2013	IMG_2013 0528_152 629	N	bridge	N 4,252,326.76383  E 476,498.82399	19 S.	70 W.	6	15
